總說明 .....	1
<b>台北市公共藝術管理維護準則之研究</b>	
第一章 緒論 .....	2
一、執行方法與架構 .....	2
二、調查方法與流程 .....	4
第二章 台北市公共藝術總體檢報告 .....	5
一、作品分類與評估 .....	5
二、專業勘察報告.....	11
三、資料彙整結果分析.....	13
第三章 公共藝術問題類型與改善方法.....	33
一、調查方法與流程說明.....	33
二、問題類型與改善方法.....	33
第四章 國外法令經驗分析比較與具體維護改善計畫.....	55
一、國外法令分析.....	56
二、國外管理維護經驗 .....	57
三、兩件具體維護改善計畫 .....	58
第五章 「台北市公共藝術管理維護準則」草案.....	69
一、台北市公共藝術管理維護準則.....	69
二、台北市公共藝術管理維護操作手冊.....	74
<b>附 件</b>	
一、參考書目.....	80
二、「溫哥華政府維護管理政策報告」中文翻譯與原文 .....	81

# 總說明

# 第一章 緒論

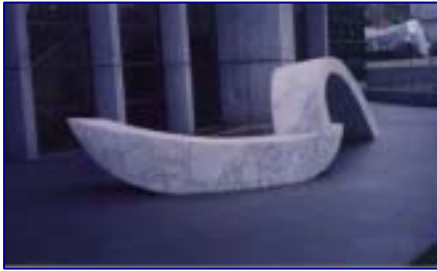
## 可以保留 2

作品名稱：平衡與使之平衡	位置：民生東路/復興北路口
材質：大理石	作者編號：E04-105-00
作品檢視內容：作品狀況良好

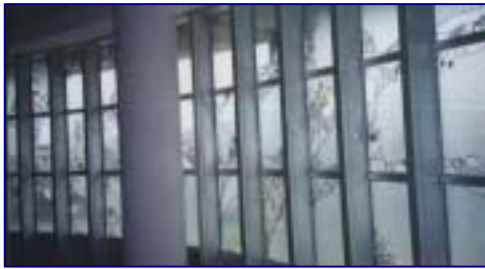
## 可以保留 3

作品名稱：百草圖	位置：中醫研究所大門口上方
材質：鑲嵌玻璃	作者編號：P25-112-00
作品檢視內容：作品狀況良好

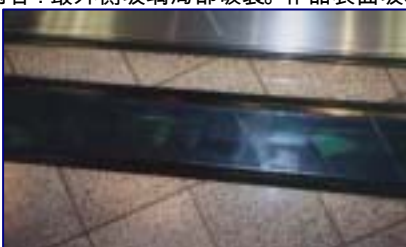
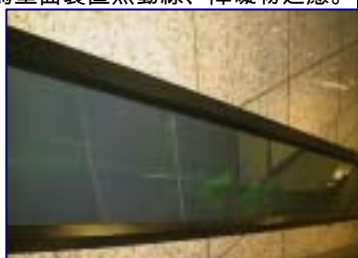
#### 有待維修 1

作品名稱：非想·想飛	位置：捷運中正紀念堂金華街出口
材質：全像攝影、玻璃	作品編號：87-29
作品檢視內容：最外側玻璃局部破裂。作品表面玻璃骯髒。	環境檢視內容：為壁面裝置無動線、障礙物之慮。 具有基本 日夜間照明。

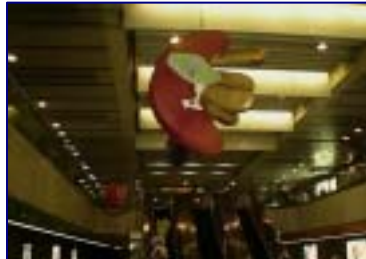
#### 有待維修 2

作品名稱：邂逅	位置：捷運古亭站內
材質：樹脂、防火漆	作者編號：87-32
作品檢視內容： 作品狀況良好 作品有積大量灰塵	環境檢視內容：應增設重點日夜間照明 無英文說明； 菱形尖角造成 壓迫感。車站 藝術品過多， 造成視覺混淆 失去焦點

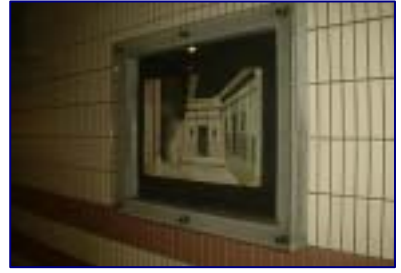
#### 有待維修 3

作品名稱：流金歲月	位置：萬華車站剪票口通道牆面
材質：陶板	作者編號：P21-108-00

環境檢視內容：應增設重點日夜間照明  
無英文說明

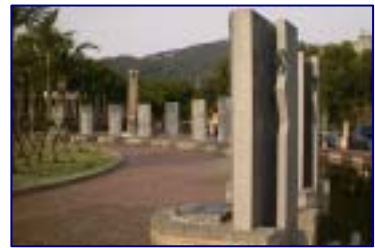
**有待維修 4**

作品名稱：板岩石雕	位置：原住民主題公園
材質：石材	作品編號：E17-111-00
作品檢視內容： 輕度人為塗鴉 表面堆積污垢 狀況良好	環境檢視內容： 作品動線具引導性， 作品與周圍環境 配合 具基本日夜間照明

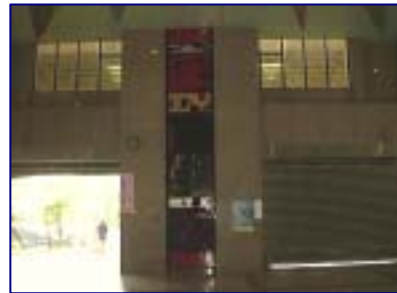
**有待維修 5**

作品名稱：本位 2000-1	位置：萬華車站大廳內部牆面
材質：漆畫	作者編號：P20-108-00
作品檢視內容： 作品框架局部掉漆	環境檢視內容：作品具識別性、引導性與空間使用特性 有基本日夜間照明， 作品尺度與基地適宜 無中英文說明

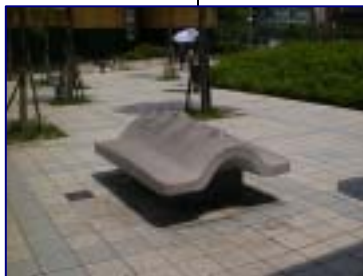
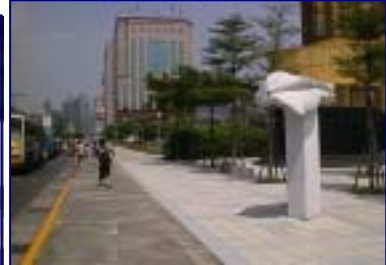
**有待維修 6**

作品名稱：成長(2 件)	位置：捷運市政府站
材質：青銅、大理石、花崗岩	作者編號：88-34A，88-34B
作品檢視內容：花崗岩部分局部崩裂；石材作品表面油漬、髒污、 作品表面風化	環境檢視內容：作品具識別性、引導性與空間使用特性； 無基本日夜間照明；應設置重點照明

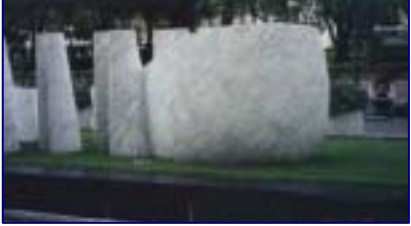
**有待維修 7**

作品名稱：暢流	位置：交通部運輸研究所大前花台
材質：大理石	作者編號：87-43

<p>作品檢視內容：作品表面髒污(藻類)；          作品狀況良好</p>

<p>環境檢視內容：作品具識別性、引導性與空間使用特性；          有基本日夜間照明、作品尺度與基地適宜          無英文說明、作品花台台座出現白華現象</p>

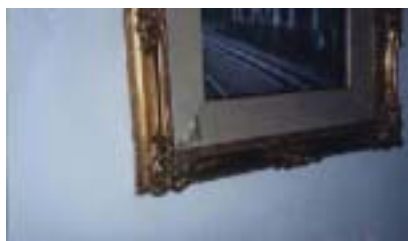
### 有待維修 9

作品名稱：光影的軌跡-數位畫廊	位置：萬華車站第一月台
材質：複合媒材	作者編號：P24—108-00
作品檢視內容：作品畫布表面遭人為割破	環境檢視內容：作品具識別性、引導性與空間使用特性 有基本日夜間照明 作品尺度與基地適宜 部分燈具尚須維修

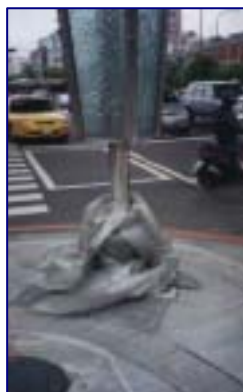
### 有待維修 10

作品名稱：時間斑馬線	位置：敦化北路/市民大道口
材質：H 型鋼、強化玻璃	作者編號：88-18
作品檢視內容：作品表面髒污，水漬 鋼材鏽蝕 部分鋼架 被包裹著氣泡布	環境檢視內容：作品具識別性、引導性與空間使用特性；有基本日夜間照明；作品尺度與基地適宜；作品基座鏽蝕

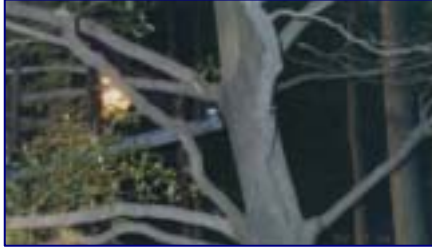
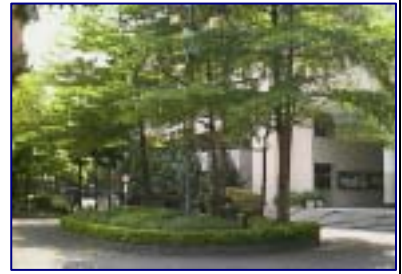
### 有待維修 11

作品名稱：大安樹	位置：大安高工校門口
材質：5mm 延壓銅板彎製、玻璃、高壓鈉燈	作品編號：88-58

作品檢視內容：部分燈具遺失；標示牌附近草太長，且照明不足

環境檢視內容：作品具識別性、引導性與空間使用特性  
具有基本日夜間照明  
作品尺度與基地適宜  
作品造型與周圍小葉  
橄仁搭配恰當

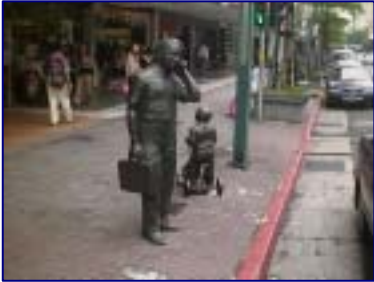
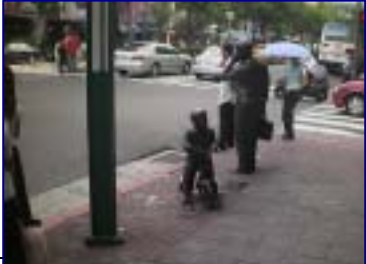
#### 須再勘驗 6 (鑄銅)

作品名稱：生活頌	位置：重慶北路一段華陰街口
材質：鑄銅	作品編號：88-46
作品檢視內容： 作品表面髒污。 表面挫傷，留有刮痕、漆片。 作品附近為垃圾車停靠處，因此附近居民會將垃圾集中在此處，對作品而言是一件很尷尬的事。

環境檢視內容： 由於街角擁擠，一致的鋪面無法凸顯藝術品。 藝術品與週遭環境之配合’ 街道燈具位置阻礙作品可及性 街角鋪面可配合藝術品作考量，使其有別於人行道鋪面，以增加作品的自明性。

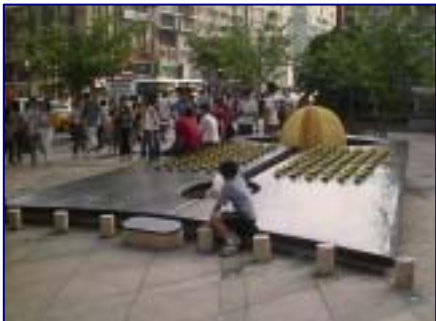
### 須再勘驗 11 (琉璃)

作品名稱：平安鐘	位置：忠孝東路 3 段頂好廣場
材質：琉璃	作品編號：E07-106-00
作品檢視內容： 琉璃部分破損 螺絲遺失 水池髒污 無夜間照明	環境檢視內容：作品不具引導性與空間使用特性 廣場空間侷促，人潮擁擠，藝術品佔地面積過大，限制使用功能性

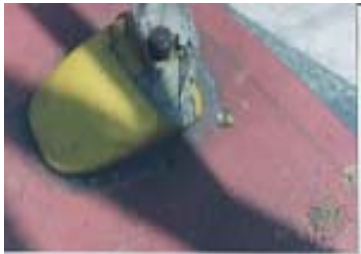
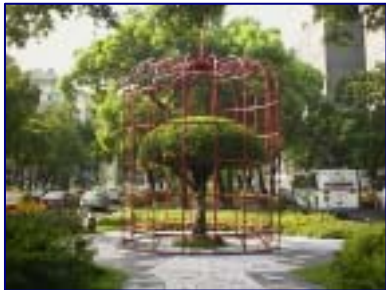
**須再勘驗 13 (不繡鋼)**

作品名稱：鳥籠外的花園	位置：敦化南路/安和路口
材質：1.不繡鋼+FRP 2. 混凝土+FRP	作品編號：88-20
<p>作品檢視內容：</p> <p>鳥籠上漆剝落</p> <p>FRP 小鳥斷裂、遺失</p> <p>椅子上漆面起泡、龜裂</p>	<p>環境檢視內容：</p> <ul style="list-style-type: none"> <li>● 作品具識別性、引導性與空間使用特性</li> <li>● 具有基本日夜間照明</li> <li>● 作品尺度與基地適宜</li> </ul>

焊接 FRP 部分與鳥籠的鐵條部分暴露在外。外側上漆的部分因與人體的摩擦，呈現正常的磨損與撕裂狀況，策展人表示，「鳥籠外的花園」備受民眾的喜愛，更是兒童時常攀爬的作品。漆彩色澤仍然鮮豔光亮，但仍有些小細部的油漆脫落。椅子的部分與鳥籠是相同的油漆成分，表面有輕微的刮傷。

椅子部分的架構良好，油漆的部分除了少數人為蓄意的破壞所致的損壞以外，表面也尚完整。有些較大的刮傷部分暴露出底層的白色油漆，應屬蓄意破壞。其中之一的椅子呈現多層油漆面，椅子背面油漆表面呈現些許泡狀浮起。因較少有人的接觸，椅子的油漆表面損壞狀況比鳥籠部分來的完好一些。

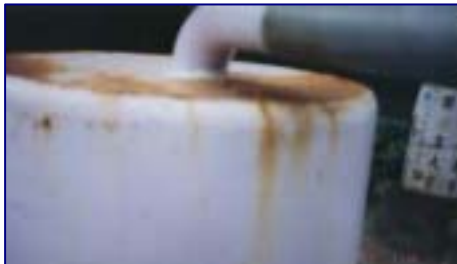
**須再勘驗 14**

作品名稱：維也納森林	位置：龍山國中
材質：不繡鋼	作者編號：88-66
<p>作品檢視內容：作品局部鏽蝕、作品被重新上過漆，作品原貌已破壞</p>	<p>環境檢視內容：作品具識別性、引導性與空間使用特性；無基本日夜間照明；應考慮學生使用上之安全性、活動空間；無中英文說明，建議遷移至腹地較大區域</p> <p>以提供學生足夠活動空間</p>

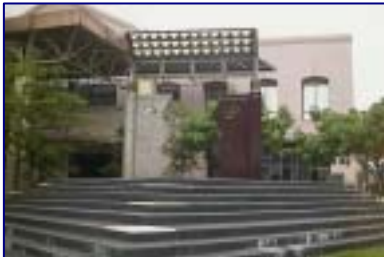
### 須再勘驗 16

作品名稱：舞陽門	位置：萬華車站戶外平台
材質：鋼材結構烤漆、觀音石	作者編號：P17-108-00
<p>作品檢視內容：作品表面遭人為破壞，局部刮痕、表面過度鏽蝕、保護層脫落</p> <p>作品烤漆表面鏽蝕脫落</p>	<p>環境檢視內容：作品具識別性、引導性與空間使用特性無基本日夜間照明，無中英文說明</p> <p>作品尺度與基地不適宜</p>

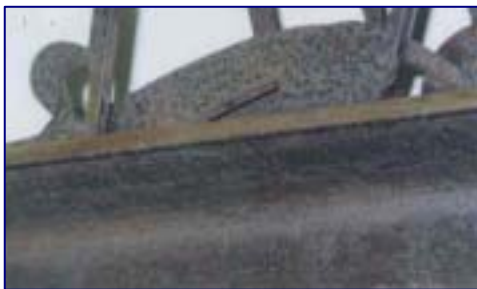
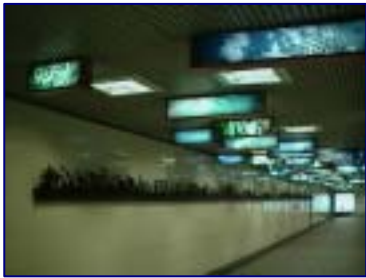
### 須再勘驗 21

作品名稱：輕鬆的雲· 走路的樂	位置：捷運中正紀念堂財政部出口
材質：鐵、燈箱、燈光片、日光燈	作者編號：87-26
作品檢視內容： <ul style="list-style-type: none"> <li>● 作品局部鏽蝕(音符部分)</li> <li>● 部分燈箱不亮</li> </ul>	環境檢視內容：作品具識別性、引導性與空間使用特性，作品的次序性有效的達到空間使用特性 <ul style="list-style-type: none"> <li>● 有基本日夜間照明，無中英文說明</li> </ul>

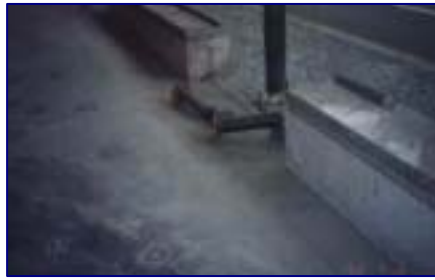
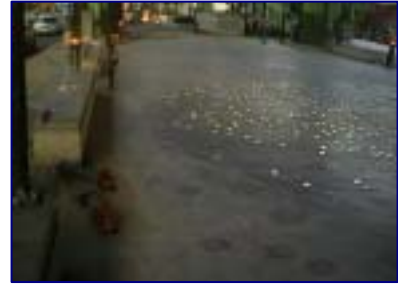
作品名稱：星光時刻	位置：市民大道/延吉街口西側
材質：鋁、銅、混凝土、金剛砂、貓眼石、玻璃纖維	作品編號：P07-105-00

作品檢視內容：燈具大多數損毀；作品鑲嵌在地面上，而地面並未維持乾淨

環境檢視內容：作品不具引導性與空間使用特性  
鋪面材質與顏色無法凸顯作品；照明損壞；鋼鑄玫瑰不明顯，可重新設計鋪面，以凸顯作品

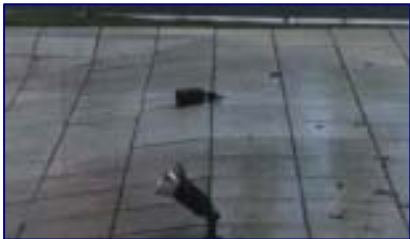
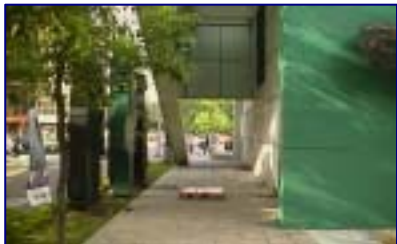
### 須再勘檢 26

作品名稱：樹河	位置：敦化南路/忠孝東路口
材質：花崗岩、不鏽鋼鏡面、燈光、水	作者編號：P05-105-00
作品檢視內容：漆面脫落、有人為破壞，局部刮痕、噴漆、部分水池無水、照明設備損壞	環境檢視內容：作品不具引導性與空間使用特性，影響殘障人士行動；具有基本日夜間照明；作品尺度與基地不適宜，造成繁忙街角的壓迫感，建議背面綠化背景

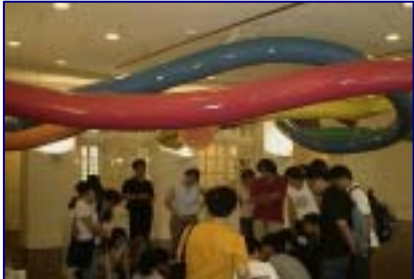
### 須再勘驗 28 (複合媒材)

作品名稱：龍	位置：台北當代藝術館大廳
材質：玻璃纖維、LED、電視、音響、燈光	作品編號：P02-103-00
作品檢視內容： 作品表面局部挫傷 烤漆脫落	環境檢視內容：作品尺度與基地不適宜；應提高作品高度，減少空間壓迫感；減少作品數量

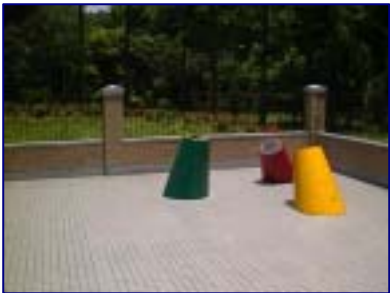
### 須再勘驗 29

作品名稱：偷窺	位置：捷運公館站
材質：玻璃纖維、投影機、攝影機、銀幕	作品編號：88-28
作品檢視內容： 遙控器遺失 FRP 表面凹陷、漆面受損 作品表面骯髒 無法執行互動裝置	環境檢視內容：作品具識別性、引導性與空間使用特性，無夜間照明，未見其互動效果，無英文說明
